The Hamlets Home Owners Association
Reserve Study
March 1, 2016

Prepared by:
William D. "Mark" Hume, PE
2MH Consulting Engineers

Association: Hamlets HOA
 Assoc. #: 0550001437

Location: Manassas, Prince William County, Virginia
 Number of Units: 47

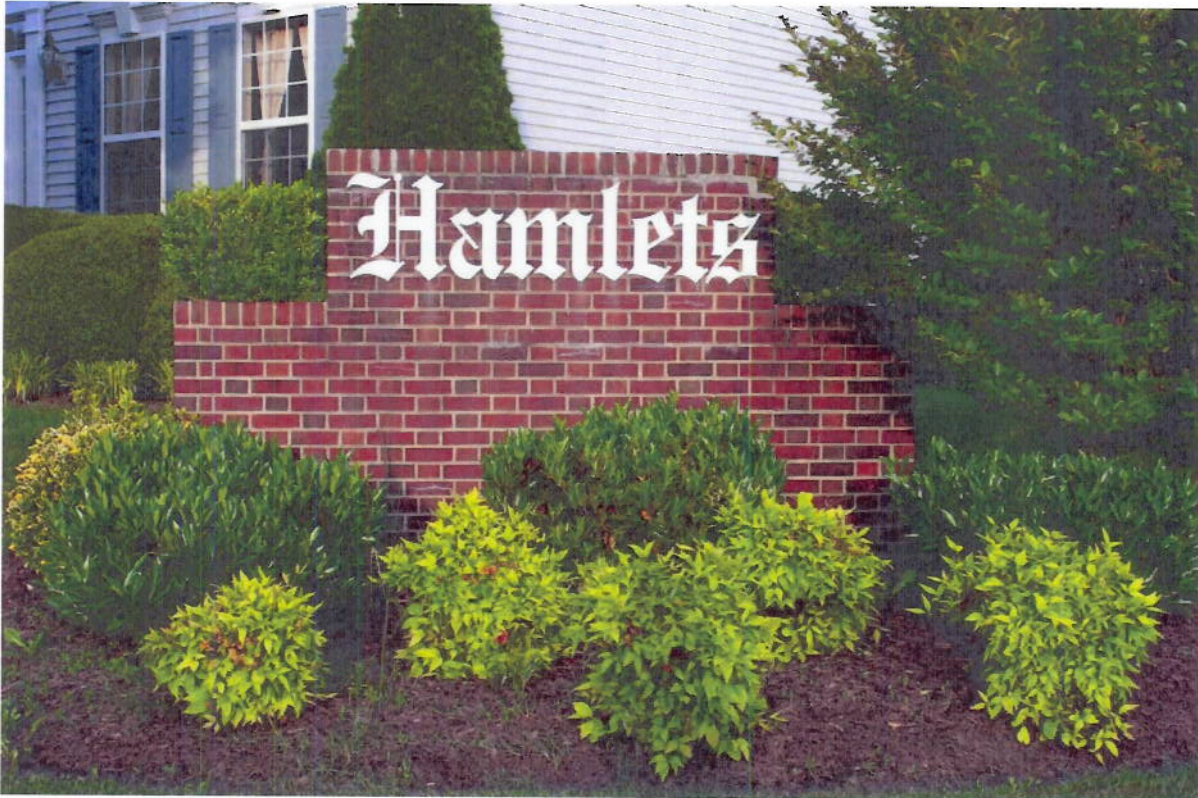
The entrance feature signs are of brick and block construction, which is inherently quite durable. They are in very good shape with minimal indications of any future maintenance issues. Multiple sources have indicated they could be expected to last more than one hundred years, with one source (claybrick.org) indicating 500 years or more. While they are around 20 years old, replacement due to deterioration should not be expected any time in the foreseeable future. We have however provided for a 30 lifespan, but estimate that the first is not likely to end for another 20 years.

Despite that apparent fact, the study provides for full replacement of the signs in ten years and periodic maintenance (cleaning and minor re-grouting, if needed) every two years.

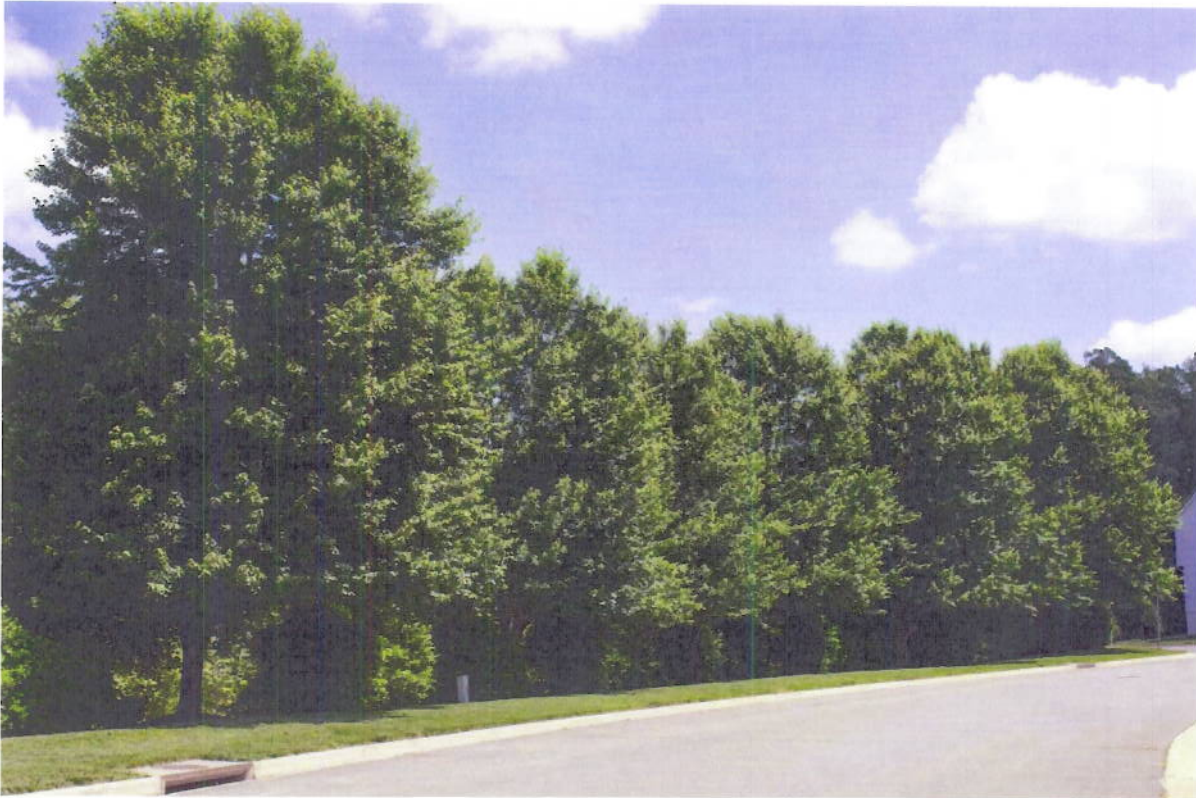
Red Maples found along portions of subdivision streets and adjacent to "Common Areas" are fast-growing and can readily achieve heights of 60-90 feet with extreme examples reaching nearly 120 feet. They have relatively short life-spans - only 80-100 years on average - with extreme examples reaching 200 years. Trees in the subdivision are nearly 20 years old, but if they remain otherwise healthy and undamaged, all will out-distance the life-spans of current home-owners.

White Pines are also fast-growing trees (two - three feet per year), referred to as "wind-breakers". They can readily achieve heights of up to 80 feet with spans of 25 feet. They also have relatively short life-spans - only 100 years on average. Trees in the subdivision are sensitive to soil moisture when adults - 20 feet high or so - which could cause premature death, but should be observed, and lacking such situations, trees in the subdivision, by inspection, appear to be are between 15 and 20 years old. If they remain otherwise healthy and undamaged, their natural life spans will carry them another 80 years.

It is estimated that pruning to some degree must occur annually, to address storm damage either from winter snows or periodic summer winds and rain. Significant maintenance and pruning is expected to recur every five years. Single tree removal/replacement due to damage or disease is predicted to occur once every three years for maples and every five years for pines.

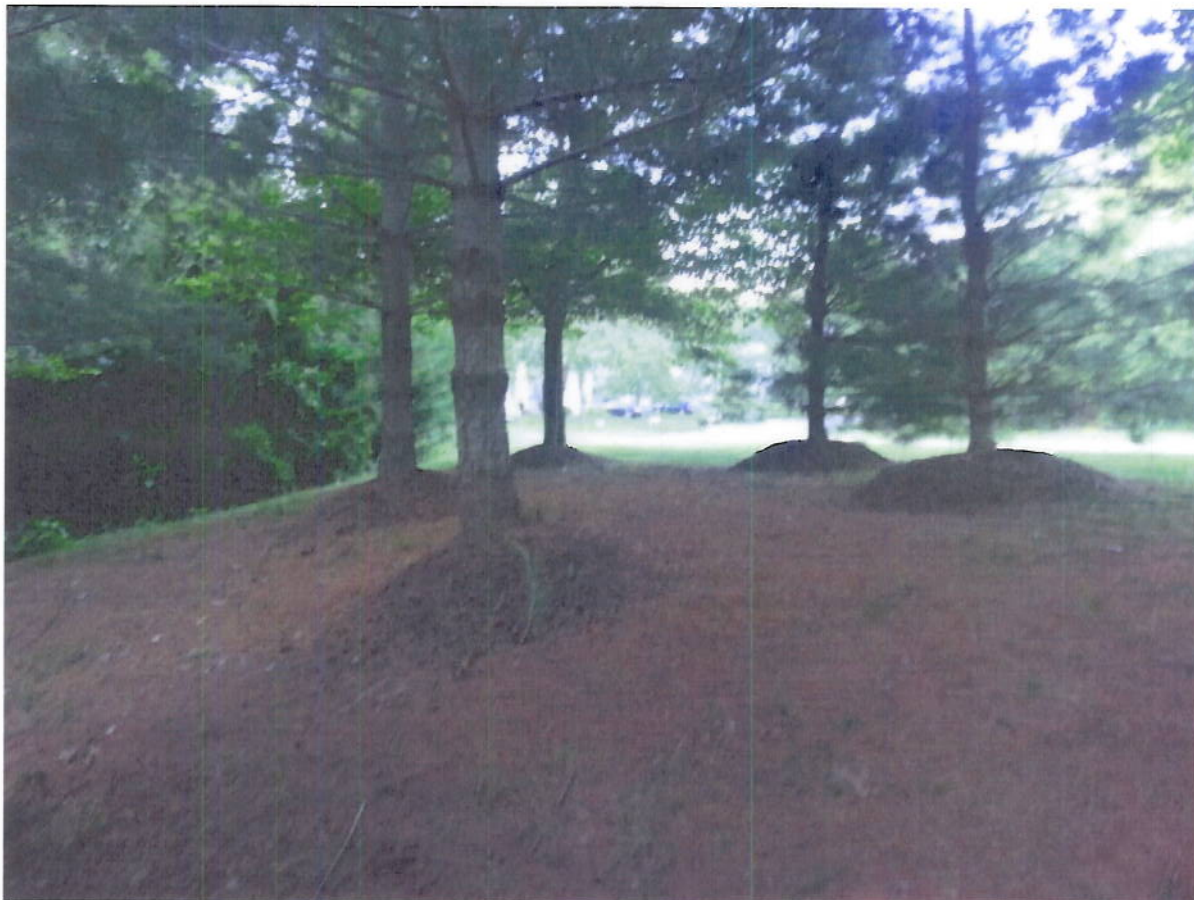
Bushes, primarily evergreens, are present primarily for screening. These are smaller, understory, varieties, but some of which can over time grow to be as much as 20 feet tall and 12 feet wide. Of these plants, arborvitae require winter maintenance, and those located under the canopy of the over-story trees, due poorly from lack of direct sunlight.

As with trees, under-story shrubs and bushes are expected to require maintenance or occasional removal and replacement, either from storm damage, or disease. Single shrub removal/replacement is predicted to occur once every three years for hollies and annually for arborvitae, which are more prone to difficulties. For hollies, this Study assumes they are at the start of the three-year return period.

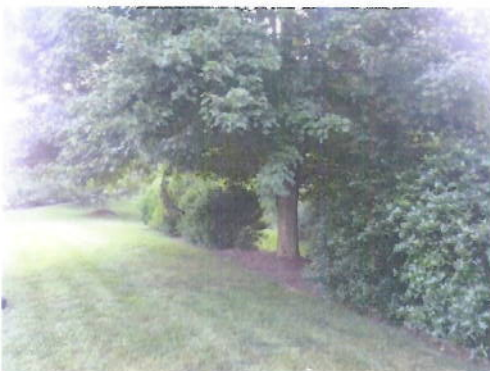
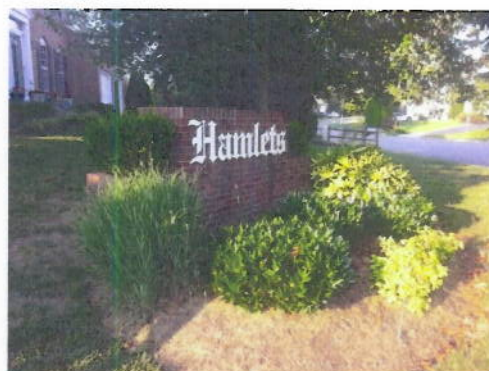
A Site Walkover during which HOA assets were identified and enumerated, was conducted on June 26, 2014 by Mark Hume, PE, Nicole Bryson, and Nancy Vernon. During that inspection each landscaping item was counted and their species later identified by Mrs. Vernon. Sketches were made of the entry monument signs and translated on the overall Subdivision Site Plan. Recurring maintenance (including replacement or removal) of landscaping elements, although not currently necessary, appear to be the most-significant Reserve Fund component. Following are some photos taken during the walkover.

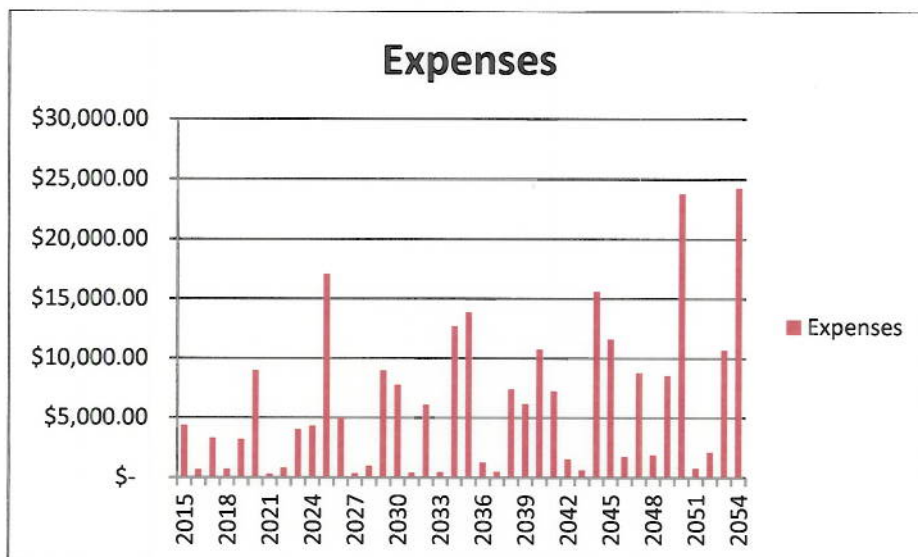
The figure below shows the array of the projected future expenses for the HOA. As with all computations in this Report, the estimates in this figure are based on conservative expense projections, meaning trending to the higher side. As you can see, expenses are projected 40 years into the future, using the Inflation rate shown in the Executive Summary (3.3%). This figure clearly shows the near term and future expenses that the Reserve Fund will face. Although tree pruning represents the most significant expense, replacement of the entrance monument structures represents the largest single expense item.

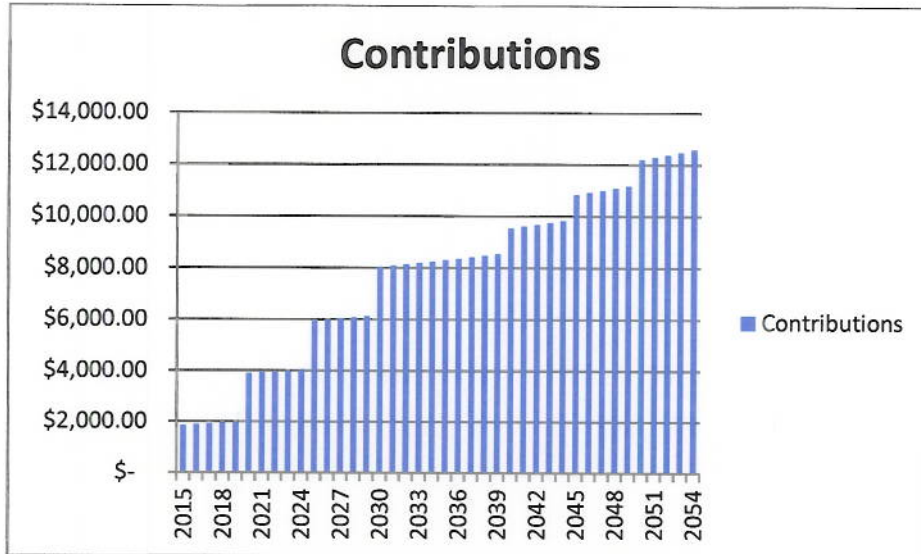
The figure below shows the array of the projected contributions to the Reserve from the HOA. Contributions are projected 40 years into the future, using the Inflation rate shown in the Executive Summary (3.3%). This figure clearly shows the near term and future expenses that your association will face. These contributions over the 40-year term will ensure the Reserve is adequately funded.

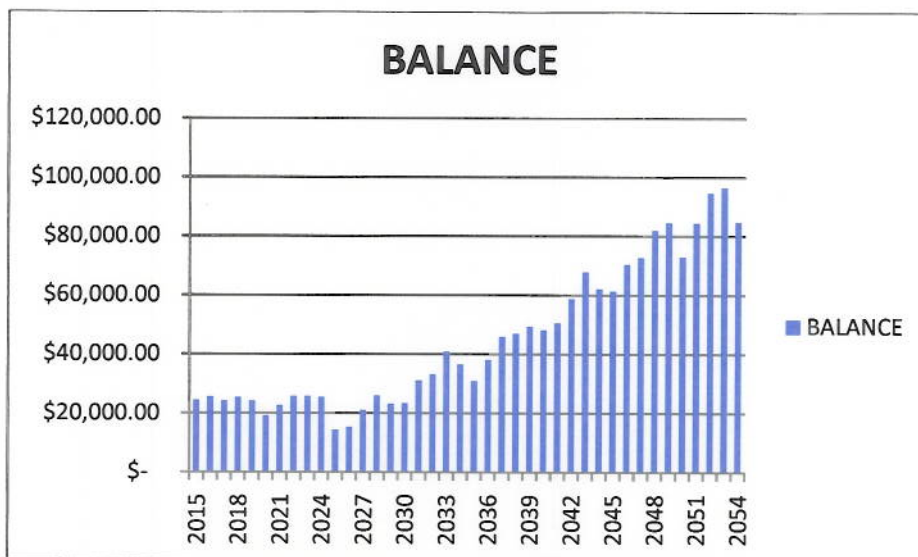
The figure below shows the projected annual reserve Balance following contributions and expenses. Contributions are projected 40 years into the future, using the Inflation rate shown in the Executive Summary (3.3%). Although the balance gets relatively larger over time, this represents an inflationary increase, and it should be noted that the 2055 expense will be over \$45,000 - these are in 2055 dollars.
